Overcoming Challenges While Rehabilitating a Corroded Aerial Sewer in a Tidal Marsh

Wayne Miles, PE, CDM
Frank Styers, PE, Cape Fear Public Utility Authority
Chris Bowling, PE, Cape Fear Public Utility Authority
Christine Nesbit, PE, CDM
Michael Sloop, PE, CDM
CDM
5400 Glenwood Avenue, Suite 300
Raleigh, NC 27612
(919) 787-5620

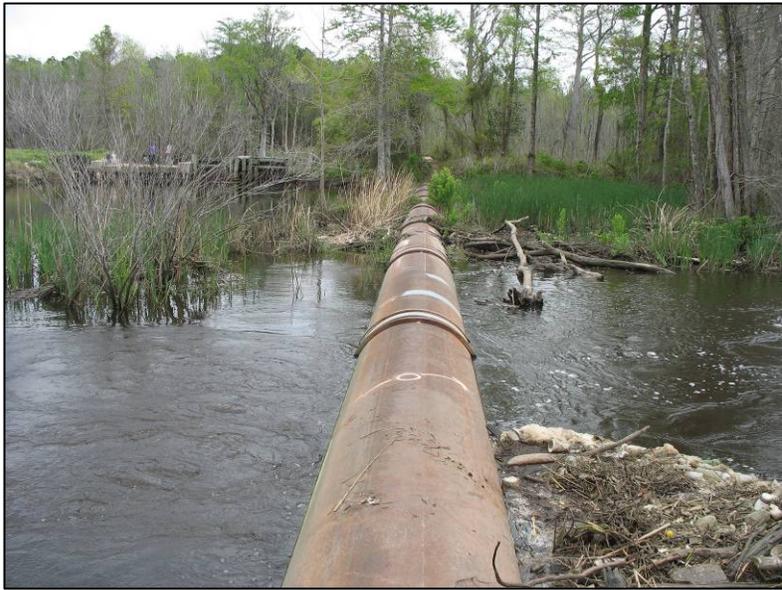
Figure 3 – View of Pipe and Retaining Straps Looking from Junction Box #2 to Manhole #1

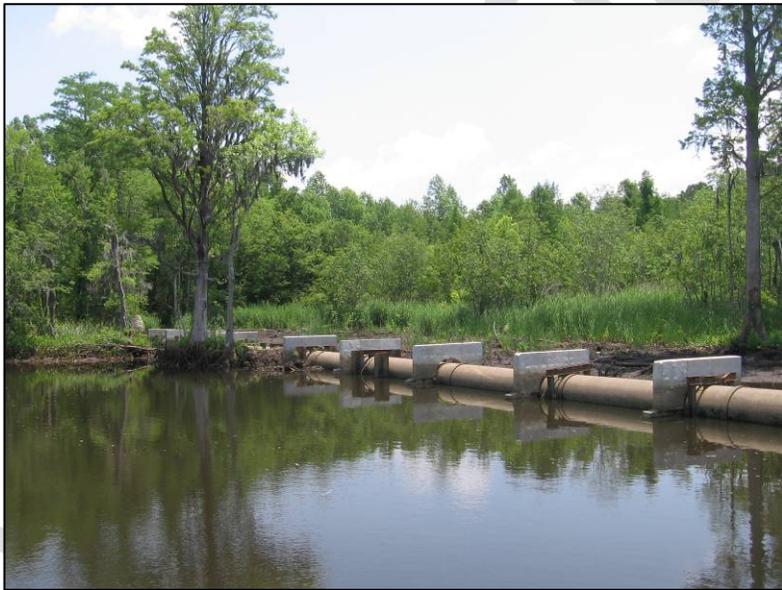
Figure 4 – View of Pipe and Concrete Piers Looking Downstream (Low Tide)

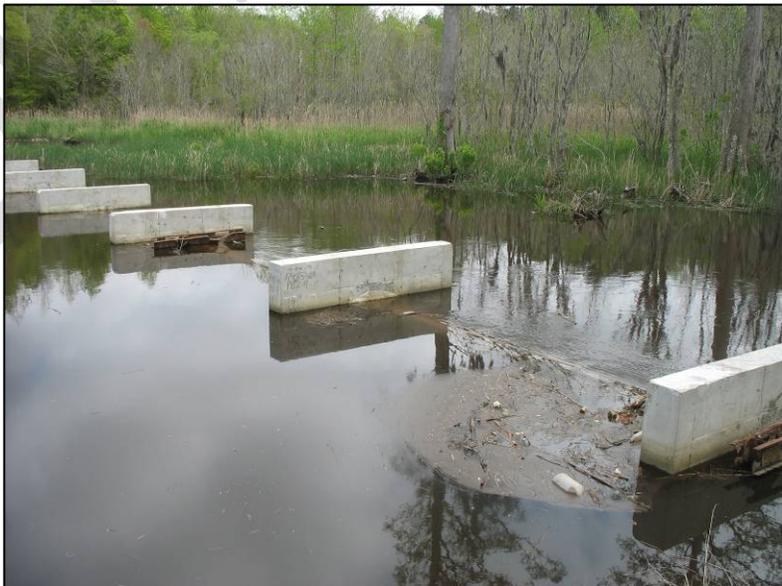
Figure 5 – View of Pipe and Concrete Piers Looking Downstream (High Tide)

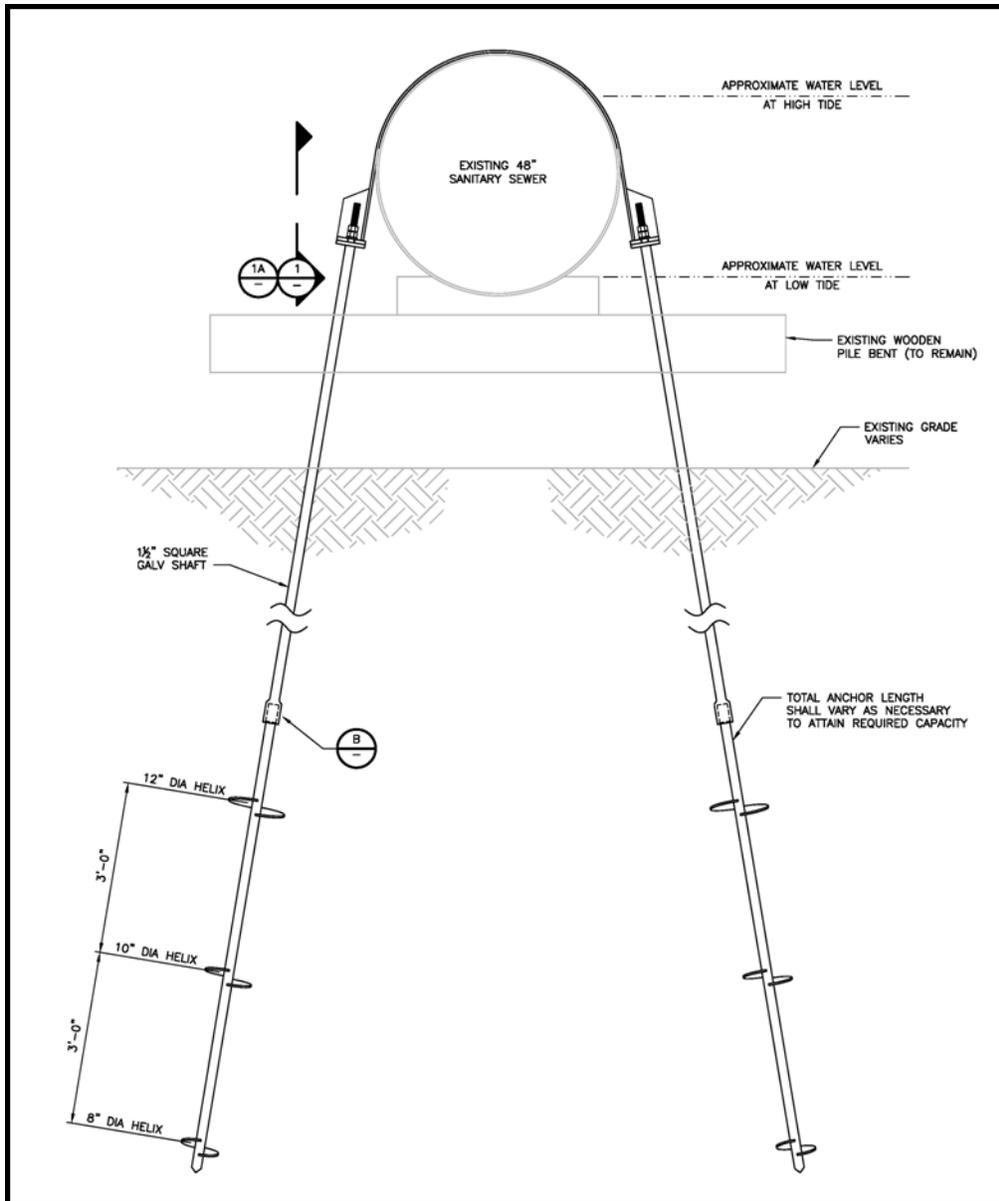
It was anticipated that pipe buoyancy would increase upon removal of the sediment in the pipe. Therefore, the helical anchor design was reviewed during the design of the pipeline rehabilitation. New anchors had been installed only three years previously as part of a previous pier improvements project, and the design was consistent with current design needs. Despite this review, however, the anchors failed upon removal of the sediment. As a result, the pipeline began to float during high tide conditions. This was a result of the anchors not being fully embedded in a hard sediment layer, thus preventing the anchors from being installed to the required depth as designed (see design detail in Figure 6).

Figure 6 – Helical Anchors Installed Three Years Prior Failed Upon Removal of Sediment in the Pipe. New Anchors with a Thicker Shaft and Smaller, Sharpened Helices Achieved the Required Installation Depth.

The anchor failure created the need for an emergency helical anchor design and construction project in a difficult-to-access project location. The pipe was kept filled with water to avoid it from floating during anchor repair.

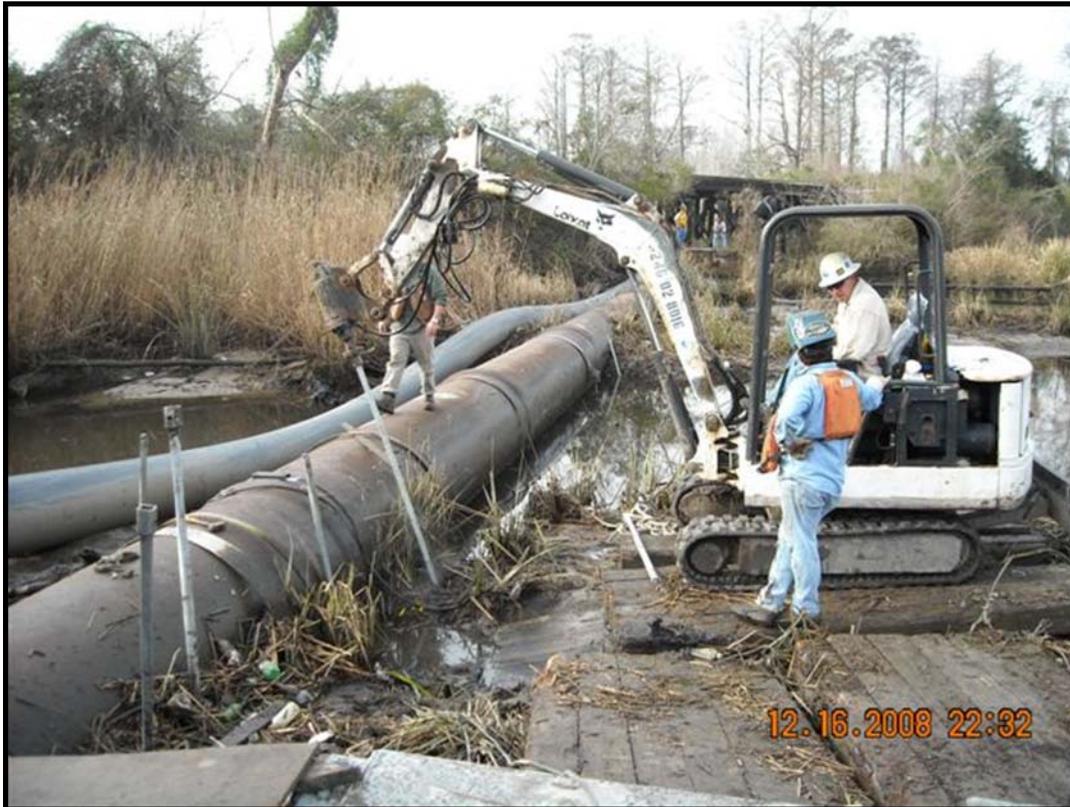
Figure 7 – New Helical Anchors Were Installed on an Emergency Basis – Thicker Shaft Anchors and Increased Installation Torque Penetrated a Hard Sediment Layer to Install Anchors to the Required Depth

In the new installation, the anchor shaft thickness was increased and the diameter of the helices was reduced to ease penetration into the hard sediment layer. In addition, the helical edges were sharpened to improve penetration into the hard layer (see Figure 7). This resulted in anchor

installation to the required depth as designed.
