CLEVER CRACKED CLEANOUT CAPS

Public education tool helps to stem inflow and infiltration

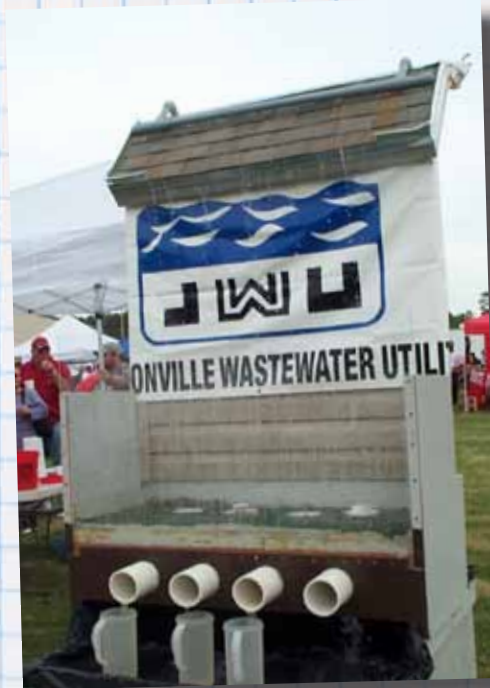
THE DISPLAY SIMULATES WHAT HAPPENS WHEN RAIN RUNS OFF OF ROOFS AND FALLS ONTO CLEAN-OUT CAPS. THE EXCESS INFILTRATION AND INFLOW LEADS TO STRESS ON THE DOWNSTREAM TREATMENT FACILITY.

The display is a trailer-mounted mockup of a series of clean-out caps with water flowing over them. Buckets below the clean-outs catch the water that passes through – what in the real world would be I/I.

The display illustrates differing conditions from a slightly broken lid to badly broken to completely missing. One clean-out is intact and waterproof. Water running from the roof provides a real depiction of how much water is allowed into the sanitary sewer system through a faulty clean-out cap.

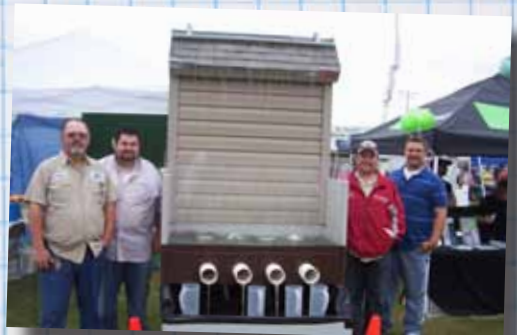
THE JACKSONVILLE (ARK.) WASTEWATER UTILITY CREATED A PUBLIC EDUCATION DISPLAY TO SHOW THE EFFECTS A BROKEN OR MISSING CLEAN-OUT CAP ON THE COLLECTION SYSTEM. THIS EDUCATIONAL PROGRAM WORKS HAND-IN-HAND WITH THE UTILITY'S PRIVATE SERVICE LINE POLICY THAT REQUIRES HOMEOWNERS TO REPAIR FAULTY SERVICE LINES.
