PUMP STRAWS

Avoiding turbulence to stop cavitation

Jim McElvogue

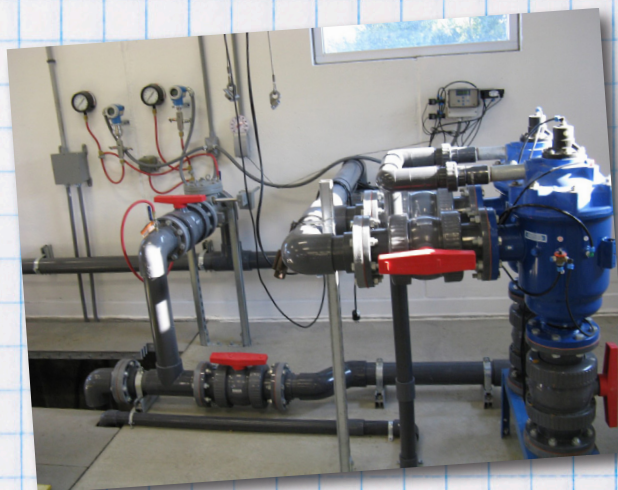
THE CITY OF AMES WATER POLLUTION CONTROL PLANT IN IOWA MOVED ITS EFFLUENT REUSE PUMPS INTO THE SAME BUILDING AS ITS NEW ULTRAVIOLET DISINFECTION SYSTEM. THE FILTERS, BACKWASH, AND PRESSURE CONTROL SYSTEM USE PRESSURE SENSORS TO RELAY INFO TO THE VARIABLE SPEED DRIVE CONTROL FOR THE PUMPS TO MAINTAIN A CONSTANT PRESSURE AND PUMPING CAPACITY.

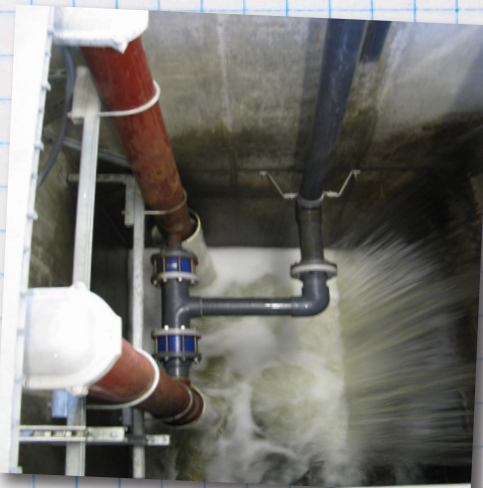
The new pump location sits directly downstream from the UV dosage control gate. As the water flows over the gate, it falls into the wet well and creates considerable turbulence near pump intakes. This turbulence caused pump cavitation and a complete loss of pressure. It rendered the effluent reuse system unusable.

THE BROWN PUMP CASINGS EXTEND INTO THE WET WELL IMMEDIATELY BELOW THE ULTRAVIOLET DOSAGE CONTROL GATE. HOWEVER, THE TURBULENCE OF THE WATER CAUSED CAVITATION IN THE PUMPS, RENDERING THEM UNUSABLE.

One possible remedy included relocating the effluent pump system. This change would mean major costs for reconstruction, plumbing, and electrical work. Another solution could have been building a baffle to deflect water with the accompanying design, construction, installation, and testing. Both were viable solutions, but the question of who would pay for the fix – owner, engineer, or contractor – was unresolved.

Then, Joseph Krebs, one of the facility's operators, offered a simple fix: move the pipe intakes away from the turbulent area. Krebs suggested building a "straw" for the intakes to pull water from a few feet down the effluent channel rather than right beneath the overflow gate.

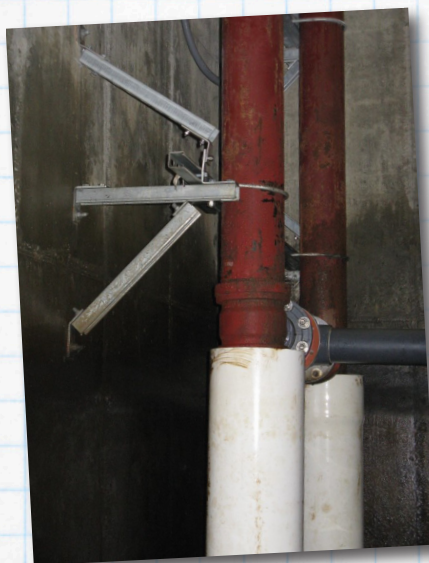
OPERATOR JOE KREBS INVENTED A SOLUTION TO THE PROBLEM BY PLACING "STRAWS," MADE OF PVC PIPE, AROUND THE PUMP CASINGS AND EXTENDING DOWN THE EFFLUENT CHANNEL. THE PIPES ESSENTIALLY MOVE THE INTAKE TO A LESS TURBULENT AREA.

City staff used stainless steel pipe restraints and anchors to attach PVC pipes to the pump intakes and routed the pipes downstream a few feet. Effluent water completely floods the end of the oversized pipe and provides a source of water not entrained with air.

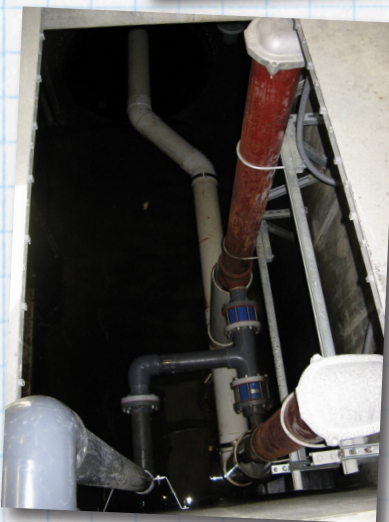
THE INTAKE PIPE (WHITE PVC SECTION) STRETCHES OUT OF THE TURBULENT PART OF THE EFFLUENT CHANNEL.

The fix restored full pumping capacity and pressure. As a side benefit, it also reduced the intake of algae that had led to pump plugging problems before. Algae that grow in the final clarifiers and ultraviolet disinfection system come loose and travel down the effluent channel. The extended intake pipe deflects the algae away from the pumps. The larger pieces of algae that used to plug the pumps can't be sucked up the extended intake in this configuration.

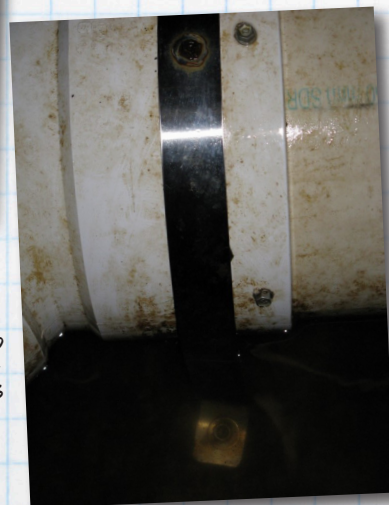
BECAUSE THE ENTIRE INTAKE PIPE TYPICALLY IS SUBMERGED, KREBS USED STAINLESS STEEL SCREWS, INSTEAD OF GLUE, TO JOIN THE PIPES. THE SCREWS OFFER MORE FLEXIBILITY IN INSTALLING THE PIPE BY PROVIDING THE MEANS TO ADJUST THE PIPE LENGTHS AND CONFIGURATION MORE EASILY.

Because leaks were not a concern, operators used stainless steel screws instead of glue to join the pipes. This allowed greater flexibility in installing the pipe by providing the means to adjust the pipe lengths and route. Installation took less than a day and cost was minimal.
