# Looking Back, What Did We Accomplish? I/I Reduction Case Studies and Lessons Learned

# Sweet Home, Oregon I/I Reduction Success Story

## Inflow & Infiltration Local Mitigation Efforts

# Locality System Monitoring and Condition Assessment (Design-Bid-Build)

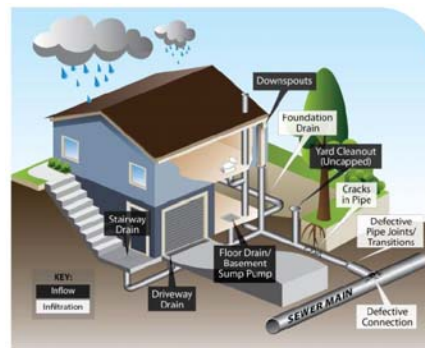
Figure 1. A diagram explaining I/I. Image by Tetra Tech  
Source: WEF, Private Property I/I Fact Sheet, 2016

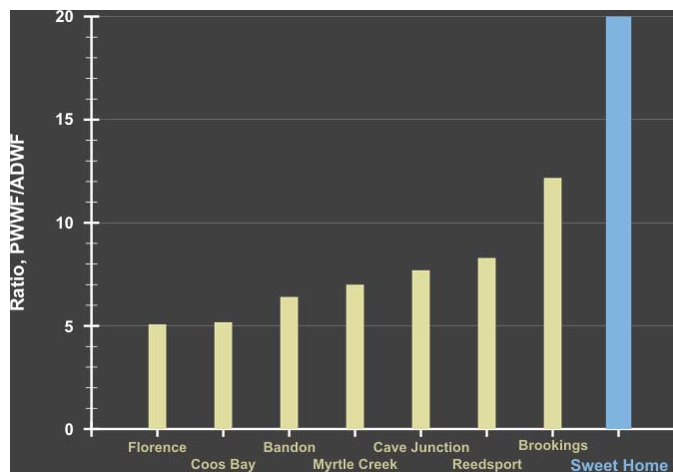
## 2002 Facility Plan showed 22:1 peaking factor

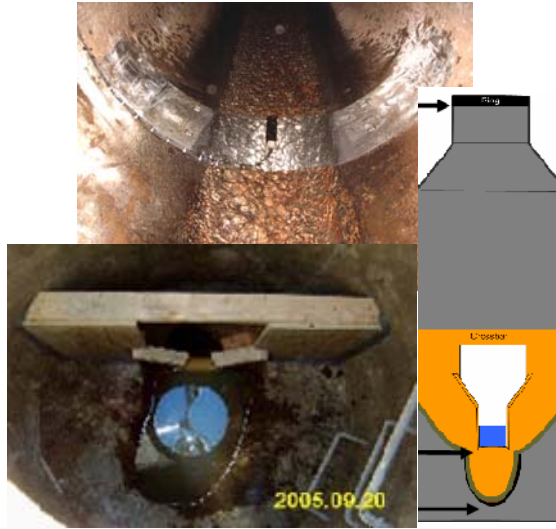
# SSES - flow monitoring

- Area-velocity meters
- Volumetric weirs
- Basin resolution increases as program evolves

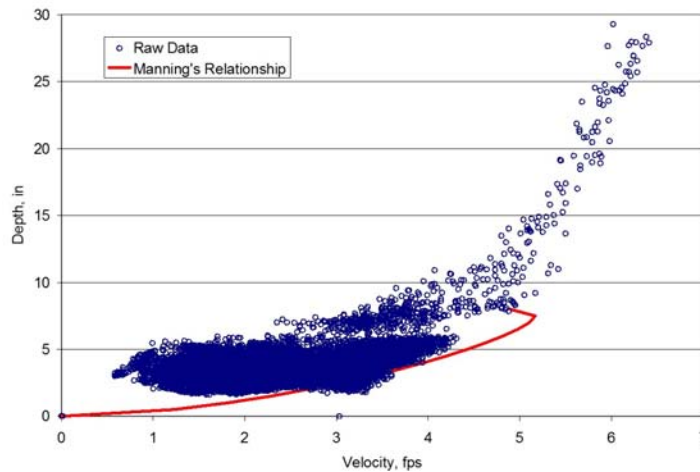
## Regular flow data check key for QA/QC

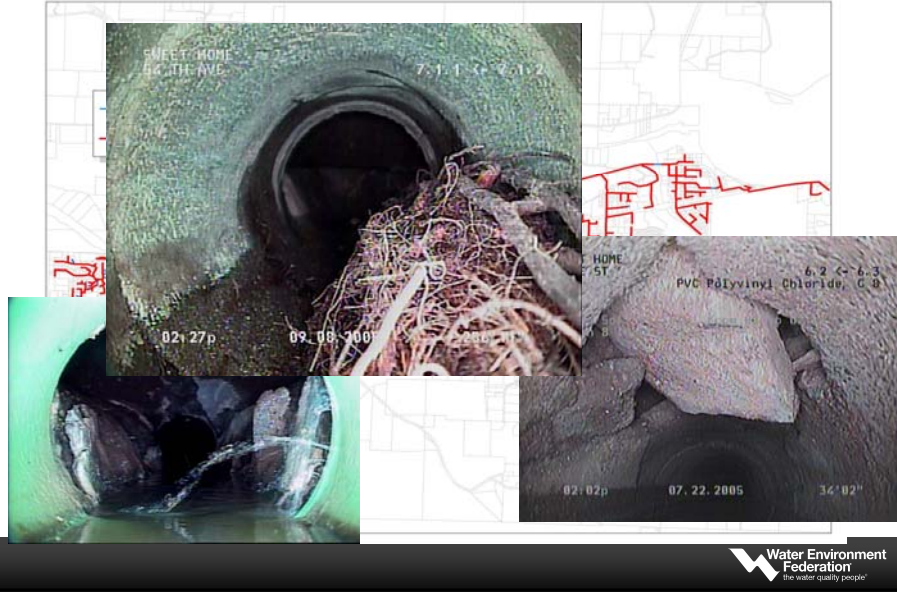
# SSES - CCTV

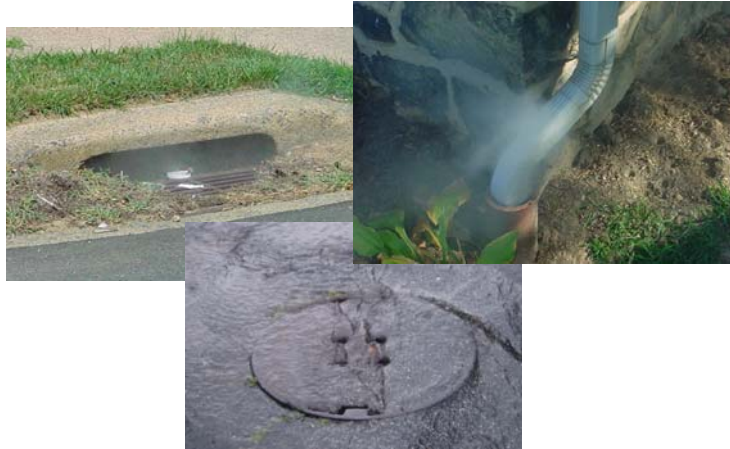
## SSES - smoke testing and MH inspections identify easy fixes

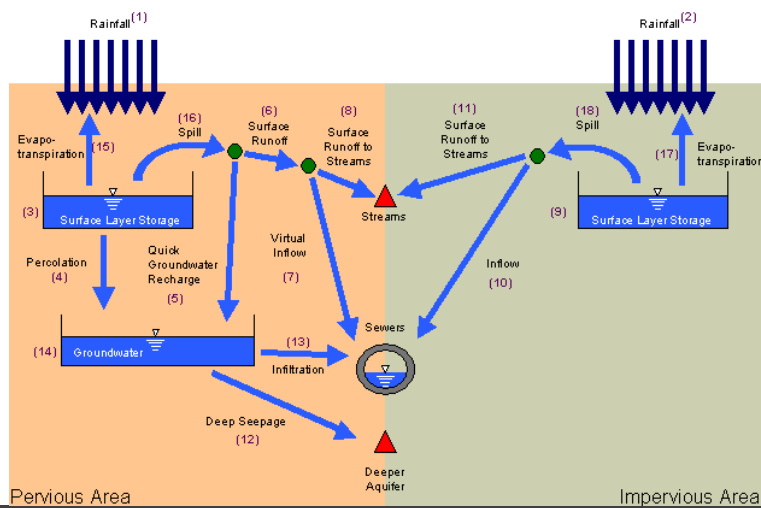
## Step 2: calibrated hydrologic models predict system response to rainfall

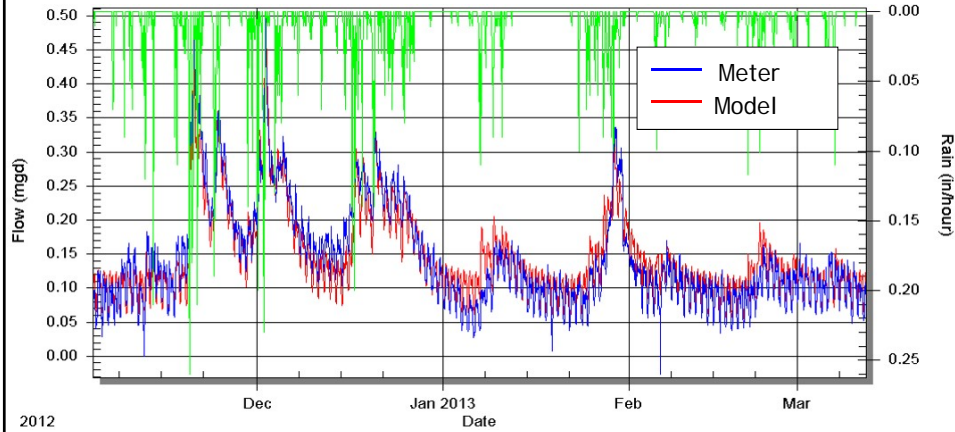
## Well-calibrated model allows confident predictions at target event

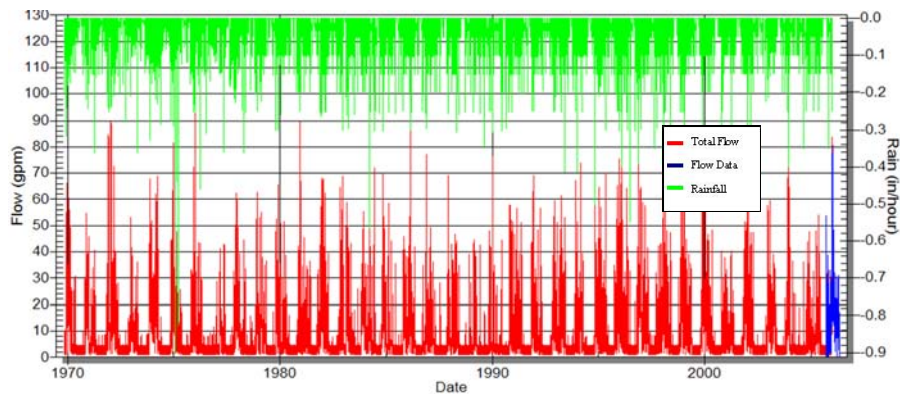
## Historic rainfall record run thru model to predict flows from large events

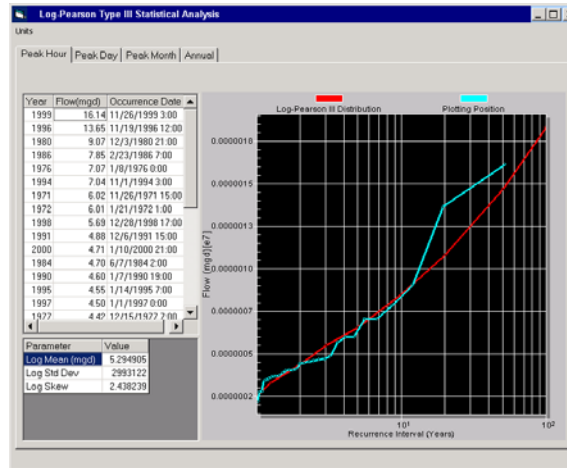
## Statistical analysis of long-term hydrograph identifies flows at various recurrence intervals

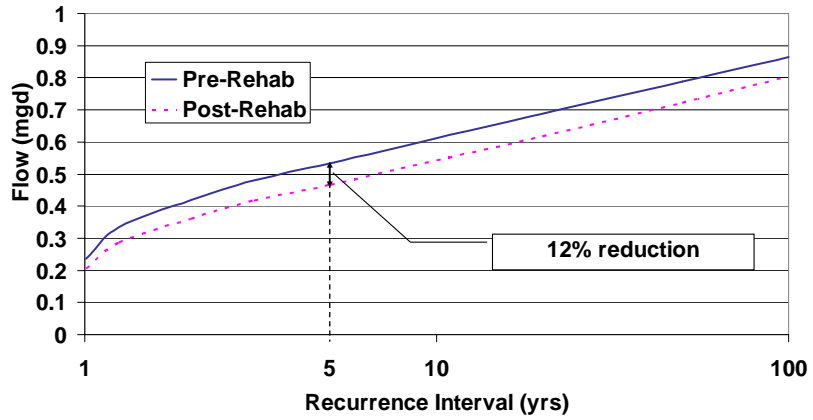
## Pre- and post-construction comparison: mains only

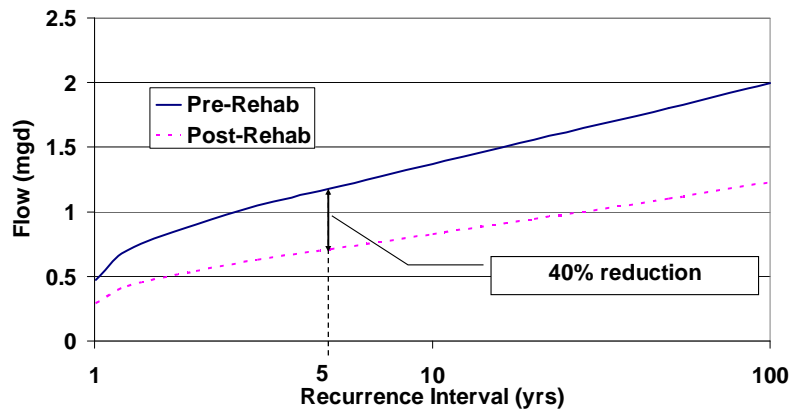
## Pre- and post-construction comparison: laterals only

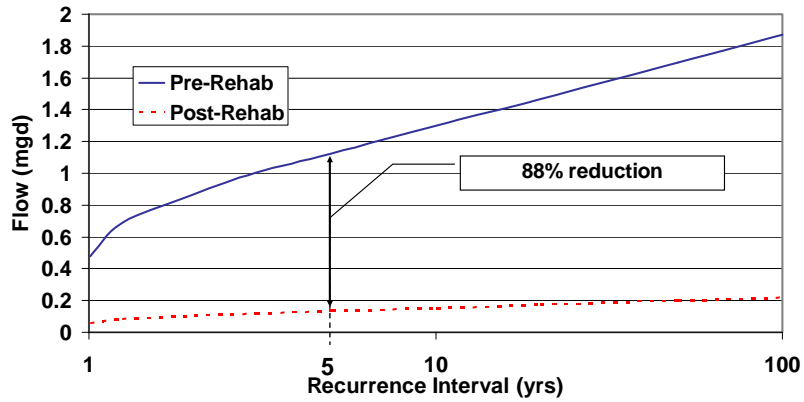
## Pre- and post-construction comparison: mains and laterals

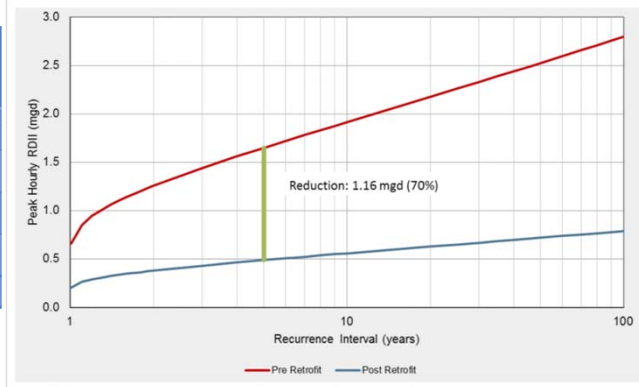
## Post-Phase 4 compared to post-Phase 3

Monitoring basin	% reduction
1	68
4 and 6	70
9	15
20	35
<b>Total</b>	<b>2.1 mgd</b>

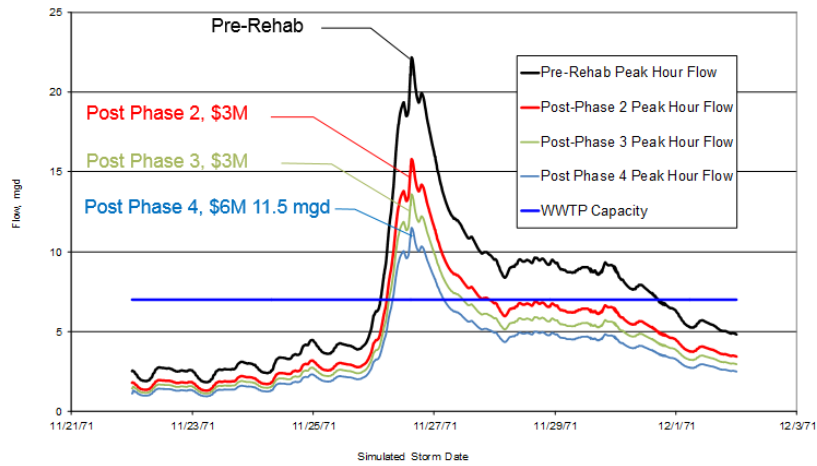
## Updated 5-year peak hour flow at WWTP

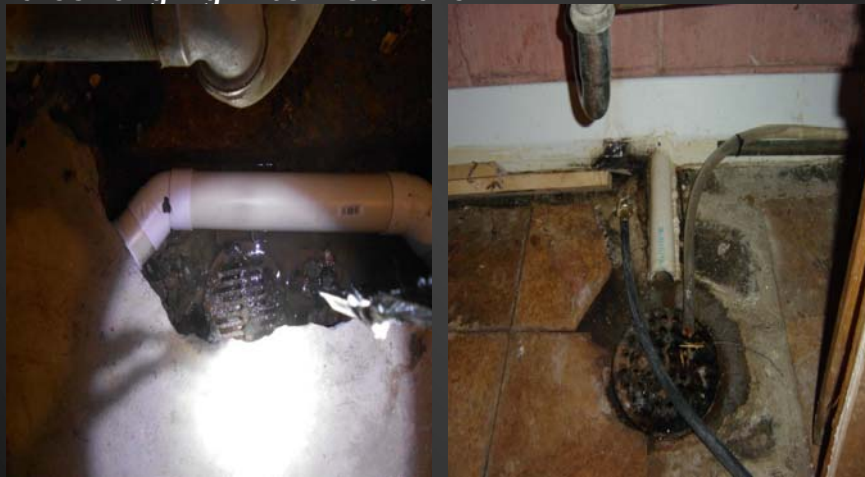
Picture on the left is a floor drain under the concrete floor, on the right is beaver board discharging into floor drain

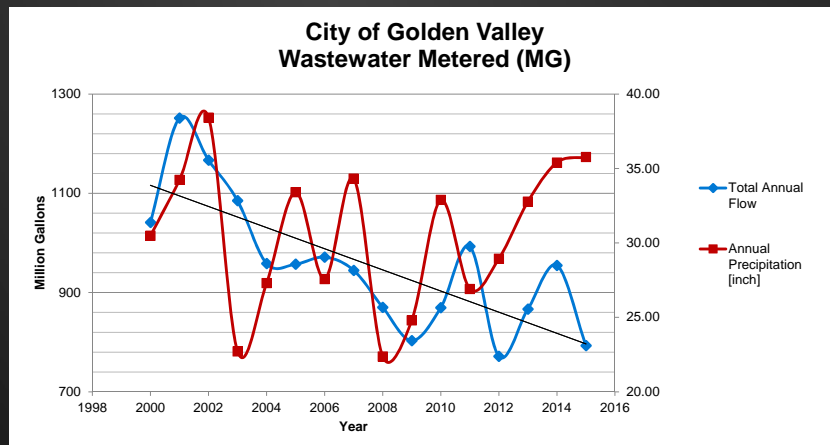
## How are we doing? *Total Flows*

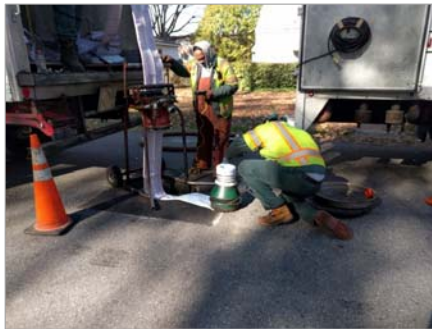
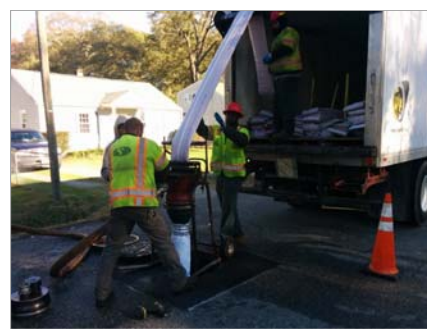
## CIPP Liner - TriState

- Liner material: Applied Felts – polyester needle felt with one side coated with polyester polyurethane
- Resin: Interplastic Corp. COR72-AT-470HT
- Curing: Steam inversion
- Liner is resin impregnated in a factory
- Liner kept in refrigerated truck to
  - prevent premature curing
- Wet out reports
