### Erosion and Stormwater Analysis of Lassing Park

Prepared By: AQUA ENGINEERING

University of South Florida Environmental Category

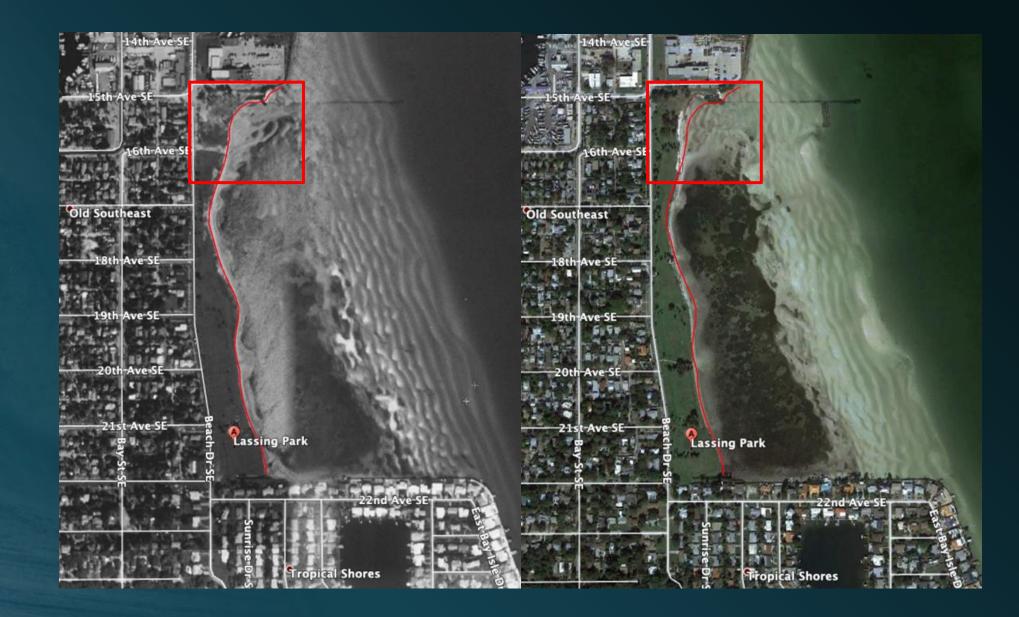
Figure I: Progression of Erosion at Lassing Park (1994 Left, 2020 Right)

- Since 1994, the shoreline has receded about 20,000 sq. feet
- Increased erosion at north end
- Rising sea levels and Florida rainy season

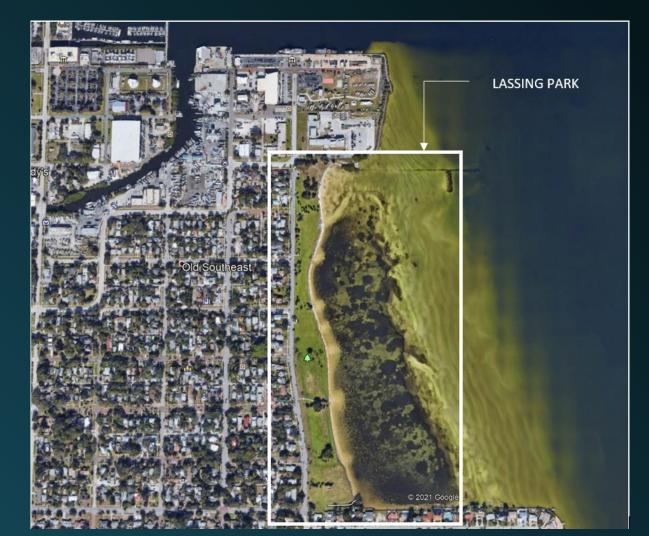
Figure 3: Satellite Image of Lassing Park

- 14.2 acre site
- 2800 ft of coastal frontage
- 2011 Tampa Bay Watch
  proposal
- 2015 AECOM Master Plan
- Community Survey

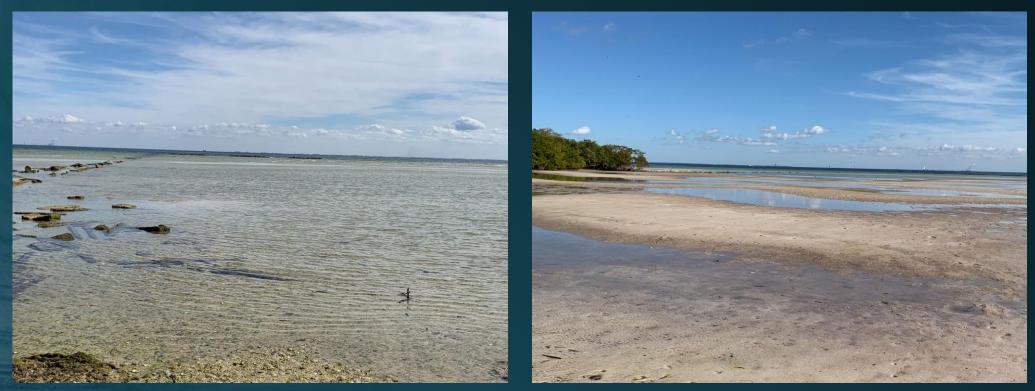
Figure 4: Current Beach Conditions at Lassing Park.

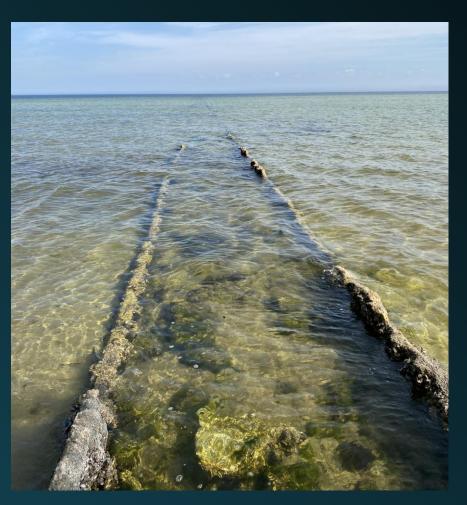
Figure 5: Satelite (left) and Field (right) Images of Existing Pier

- Sediment reservoir on the north side of the pier

- Meeting with Dr. Hapke
  - Some potential to limit longshore drift 0
  - Removal would allow new sediment to enter 0 north side of park
  - Would not need to remove subsurface 0 materials
    - Capital Cost: \$92,000
    - O&M: None -

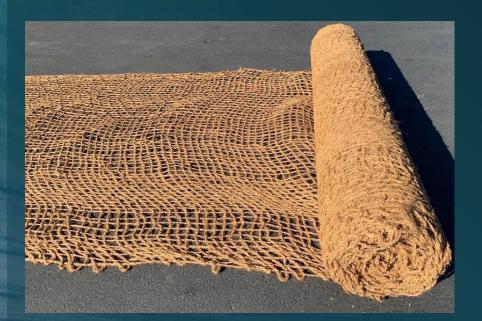
- Geotextile reinforcement mat:
  - Biodegradable coir material
  - 1835 SY, 1/2 inch thick

Figure 7: Geotextile Reinforcement Mat

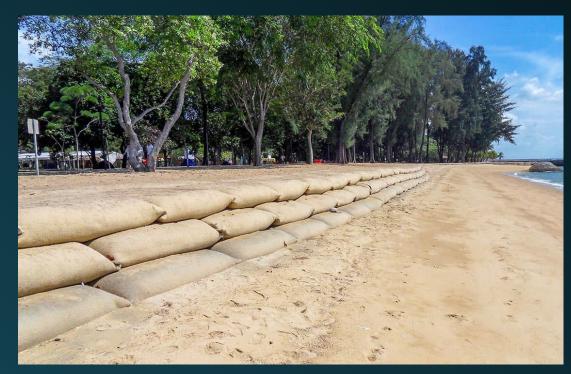
- Geotextile sandbags will form a wall:
  - 2 ft high, 200 feet long

Figure 8: Geotextile Sandbags

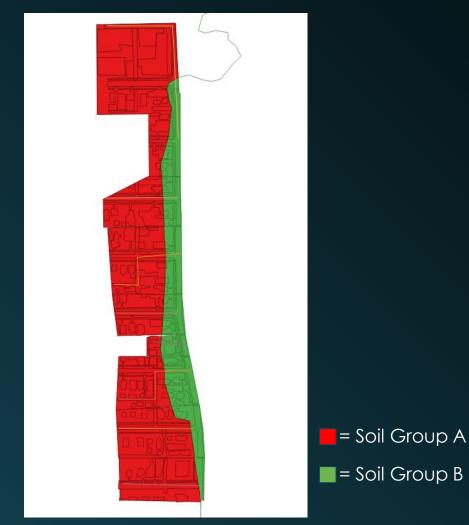
- Curve numbers for residential space are hydrologic soil group A.
- Significant difference between the results of both methods.
- Less limitations in application.

Figure 10: Hydrologic Soil Group Boundary

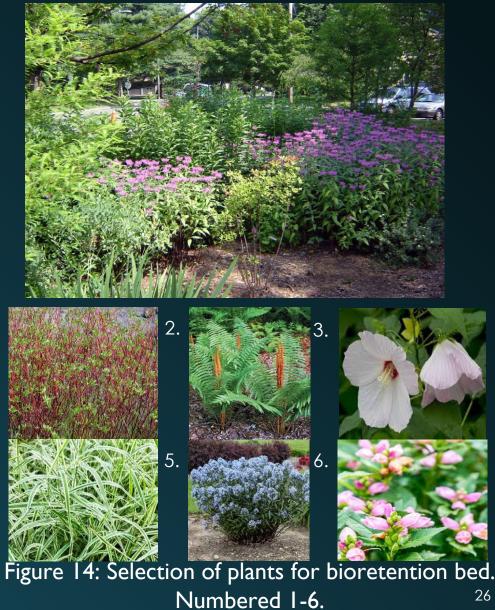
### Design Criteria:

- Depth: I ft
- Area: 0.38 acres
- FL friendly vegetation and soil
- Non-toxic to dogs
- Capital Cost: \$418,000
- O&M: \$12,000/5 Years

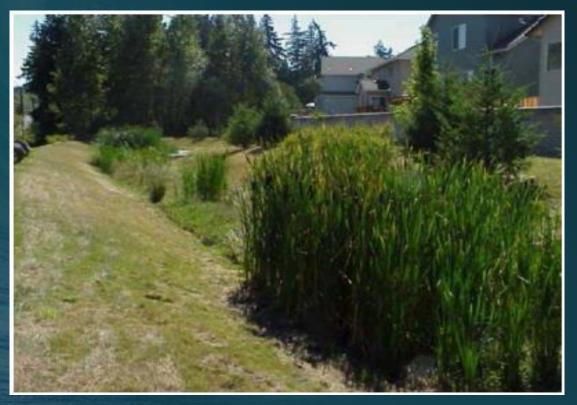
- Vegetation incorporated to existing swale
- Modification/ resloping of existing swale
- Capital Cost: \$156,000
- O&M: \$12,000/10 Years

#### Figure 13: Example of a Vegetated Swale

Parameter	Proposed
Slope (ft/ft)	1.28%
Velocity (ft/s)	4
Side Slope (ft/ft)	0.25
Roughness Coefficient	0.033
Hydraulic Radius (ft)	0.6923
