# **Piney Run Tributary Stream Restoration**

## **Student Design Competition Environmental Category**

August 27, 2021

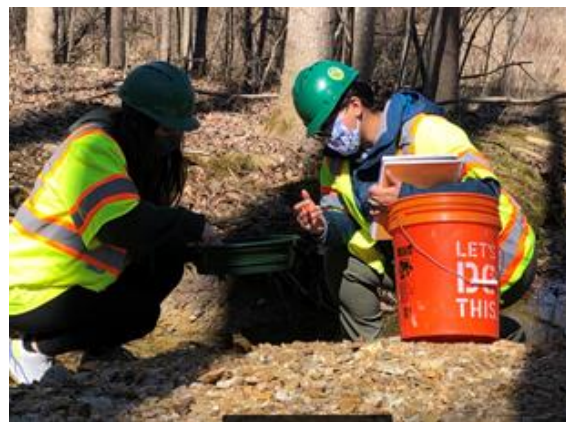
The Piney Run soil is classified as marine clay. The bed of the stream has a lot of pebbles, so a quantitative description of the bed material was done by a method of pebble count. The wetted perimeter cross-section substrate analysis method was used. 100 pebbles were collected from the wetted perimeter at normal flow. It was found that the majority of the pebbles were 3 cm long by 2 cm wide. Since the stream has a fast velocity, the sediment transport is high which causes erosion.

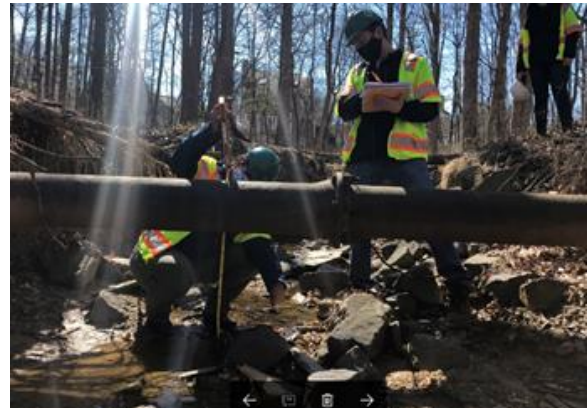
One of the main considerations made in developing potential solutions was the dire need in protecting an 8" sewer main that has become exposed. During development, the pipe was placed at the stream invert instead of the required 3' depth. Due to the major erosion the stream has faced, the pipe is now aerial and at very high risk of damage. Damage to this pipe can result in sanitary sewer overflow that would cause widespread exposure and extensive environmental damage.

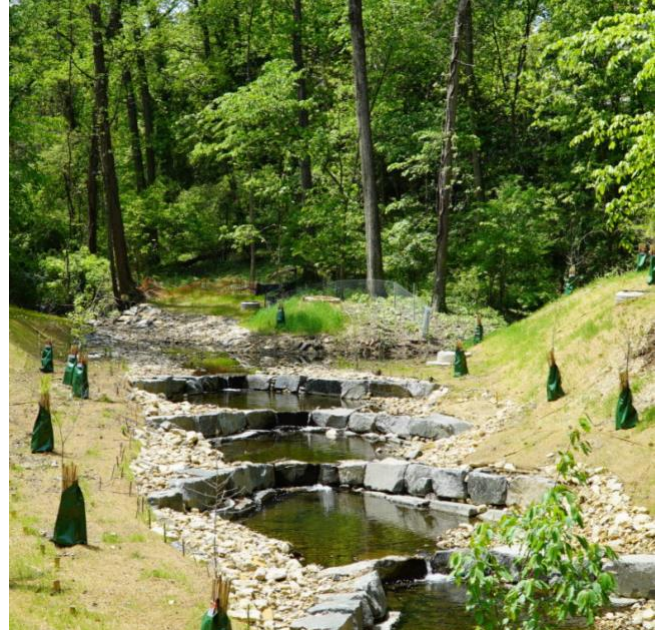
Figure #17  
Proposed Site Plan

The proposed site plan can be seen in Appendix A, Figure 17. The proposed design would result in the stream bed to be elevated by an average of 3 feet which would provide roughly 6 inches of cover

to the sewer main. The riprap installed on top will provide future protection against erosion that caused the sewer exposure.

2. Cut stream side slopes to 45° for riprap installation in areas that step pools are unable to be utilized.

3. Plant trees and vegetation that will help stabilize the stream bed and reduce flow. This measure also increases the aesthetic of the restoration as well as the ecological health of the region.
