# Weak-In Worked Out

Economical modifications help attain better biological phosphorus removal

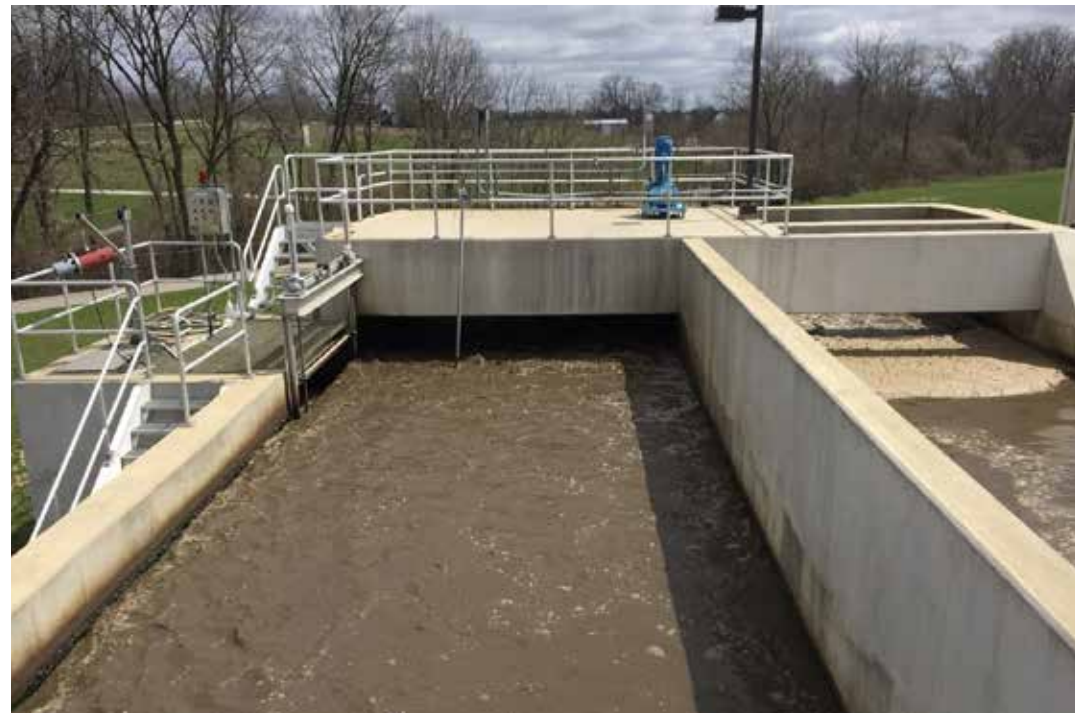
The rotor in this tank was run at minimum hertz to gain simultaneous denitrification on the back side of the oxidation ditch. Jon van Dommelen
