Overcoming Challenges While Rehabilitating a Corroded Aerial Sewer in a Tidal Marsh

Wayne Miles, PE, CDM
Frank Styers, PE, Cape Fear Public Utility Authority
Chris Bowling, PE, Cape Fear Public Utility Authority
Christine Nesbit, PE, CDM
Michael Sloop, PE, CDM
CDM
5400 Glenwood Avenue, Suite 300
Raleigh, NC 27612
(919) 787-5620

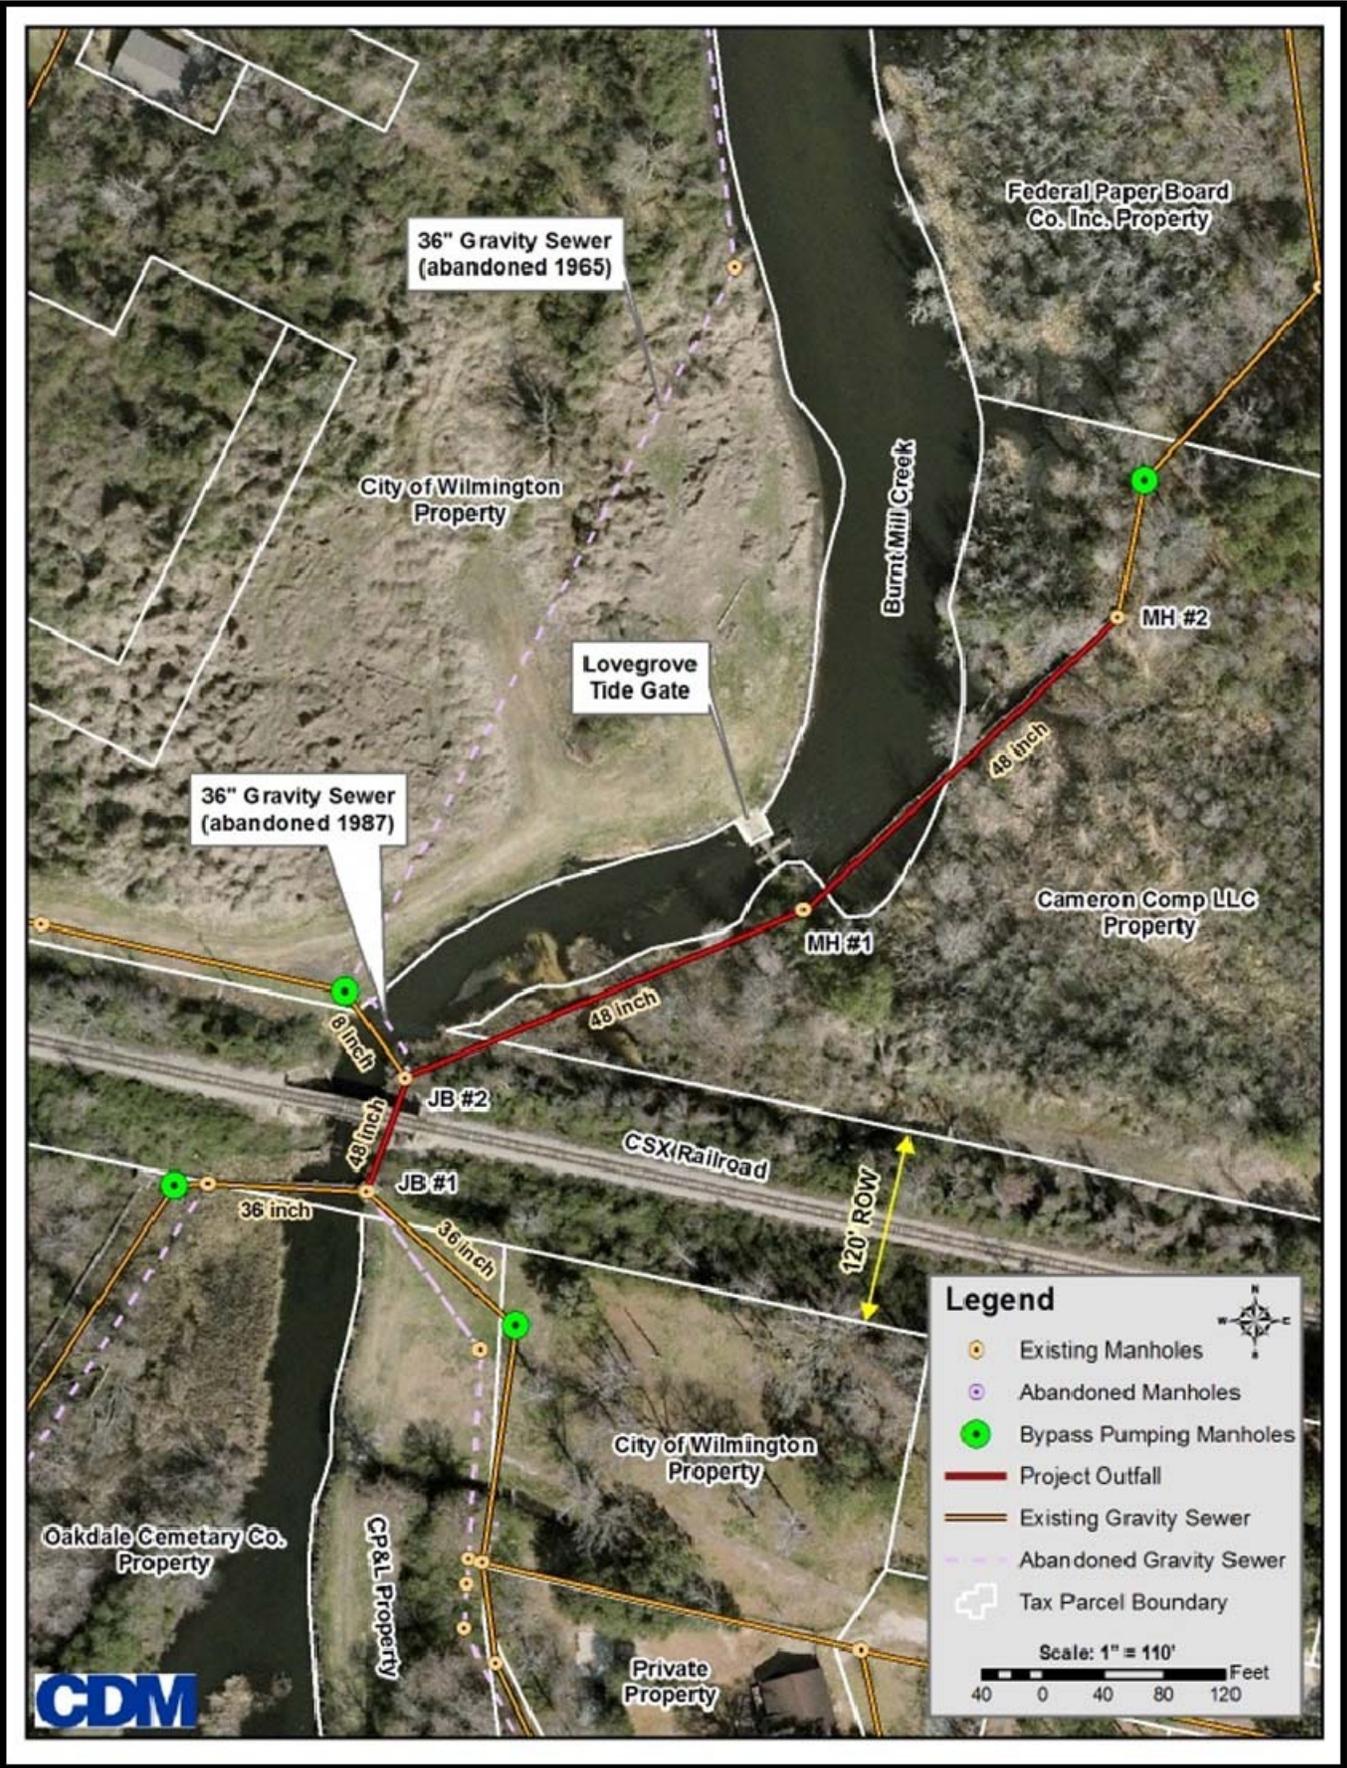
Figure 2. Map of Burnt Mill Creek Outfall Showing Location in a Tidal Marsh Area and Showing Relation to CSX Railroad Corridor

The portion of the Burnt Mill Creek outfall addressed by this project begins immediately south of a CSX railroad corridor and flows in a northerly direction, paralleling alongside and within Burnt Mill Creek, for approximately 630 feet, as shown in Figure 2.

The initial 70 feet of 48-inch diameter pipe from Junction Box #1 to Junction Box #2 is located predominately below ground and runs under the CSX railroad bridge, as shown on Figure 2. The following 280 feet of 48-inch diameter pipe is located above ground between Junction Box #2 and Manhole #1 and is supported by retainer straps, installed in 2006, spanning approximately every 20 feet. Figure 3 below shows the pipe looking downstream, with Manhole #1 and the Lovegrove Tide Gate in the background. Fluctuations in the daily tide level result in the pipe being completely above the water level to being completely inundated.
